**DEPARTMENT OF TRANSPORTATION****DIVISION OF ENGINEERING SERVICES**

Contract #: 04-0120F4Cty: SF/ALA Rte: 80 PM: 13.2/13.9File #: 69.28**WELDING INSPECTION REPORT****Resident Engineer:**Pursell, Gary**Address:** 333 Burma Road**City:** Oakland, CA 94607**Report No:** WIR-008409**Date Inspected:** 13-Aug-2009**Project Name:** SAS Superstructure**OSM Arrival Time:** 1900**Prime Contractor:** American Bridge/Fluor Enterprises, a JV**OSM Departure Time:** 700**Contractor:** Zhenhua Port Machinery Company, Ltd (ZPMC), Changxing Island **Location:** Shanghai, China**CWI Name:** Chen Xi**CWI Present:** Yes No**Inspected CWI report:** Yes No N/A**Rod Oven in Use:** Yes No N/A**Electrode to specification:** Yes No N/A**Weld Procedures Followed:** Yes No N/A**Qualified Welders:** Yes No N/A**Verified Joint Fit-up:** Yes No N/A**Approved Drawings:** Yes No N/A**Approved WPS:** Yes No N/A**Delayed / Cancelled:** Yes No N/A**Bridge No:** 34-0006**Component:** OBG sub assemblies and crossbeams**Summary of Items Observed:**

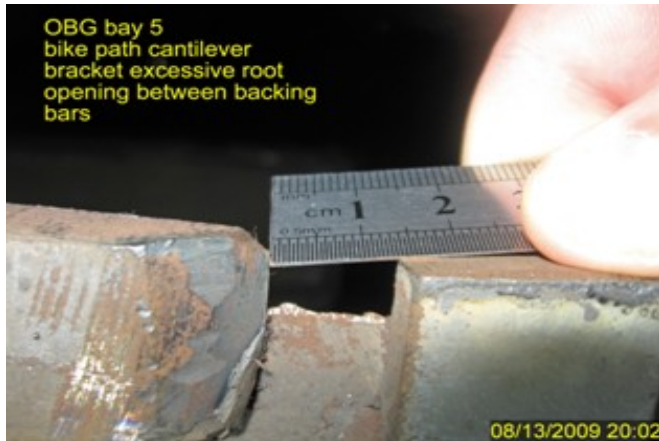
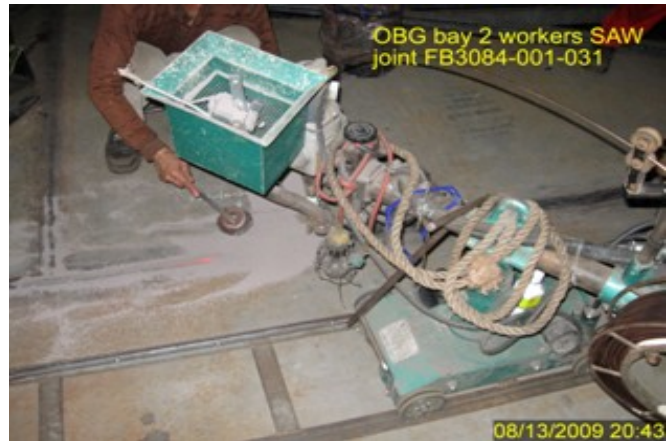
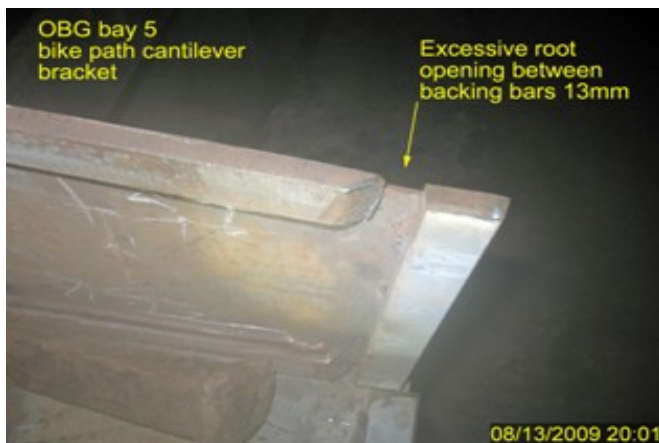
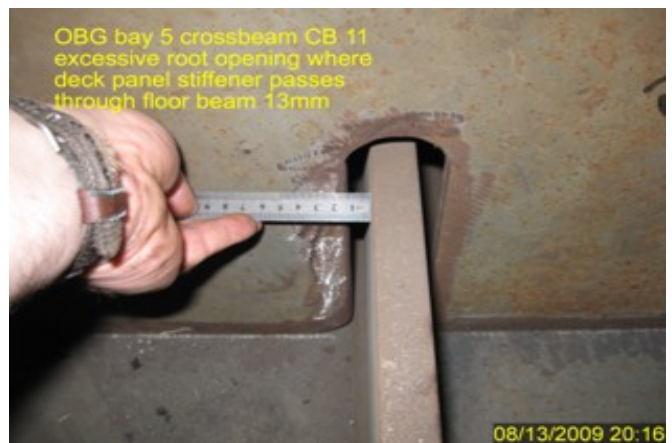
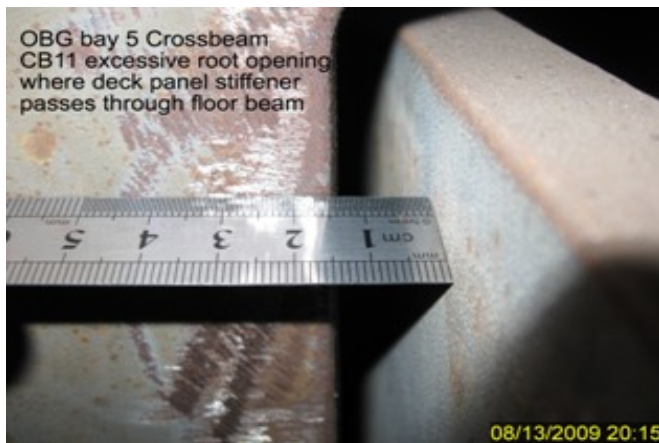
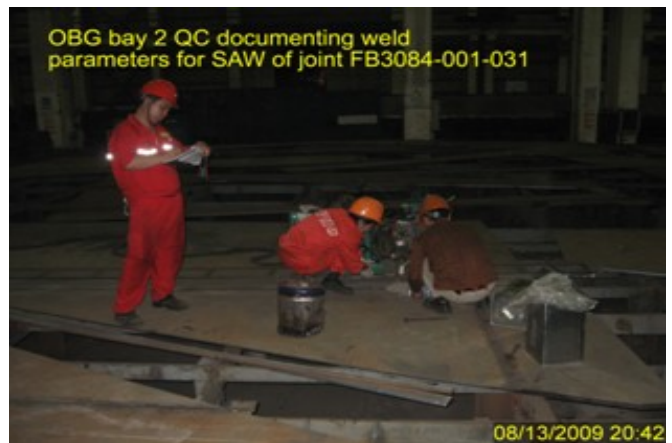
During random in process inspection of the bike path cantilever brackets this QA observed excessive root openings between backing bar strips at the corner of several of the brackets. This QA measured one of the openings at 13mm. This exceeds the maximum root opening of 5mm for Complete Joint Penetration (CJP) welds as specified in AWS D1.5 2002. See attached photos.

During random in process inspection of crossbeam CB11 this QA observed excessive root openings where the deck panel stiffeners pass through the floorbeam diaphragms. This condition exists at a number of locations in this crossbeam. This QA measured one of the openings at 13mm. This exceeds the maximum root opening of 5mm for Complete Joint Penetration (CJP) welds as specified in AWS D1.5 2002. See attached photos.

Due to the absence of QC in this bay during the time this QA was present, this QA was unable to communicate with the contractors QC concerning these issues. This QA informed Caltrans QA task leader via email of the above mentioned issues in order that dayshift QA inspectors may follow up and communicate this QAs concerns to the contractors QC inspectors.
